# The Local Oscillator

## *The Newsletter of Crawford Broadcasting Company Corporate Engineering*

AUGUST 2016 • VOLUME 26 • ISSUE 8 • W.C. ALEXANDER, CPBE, AMD, DRB EDITOR

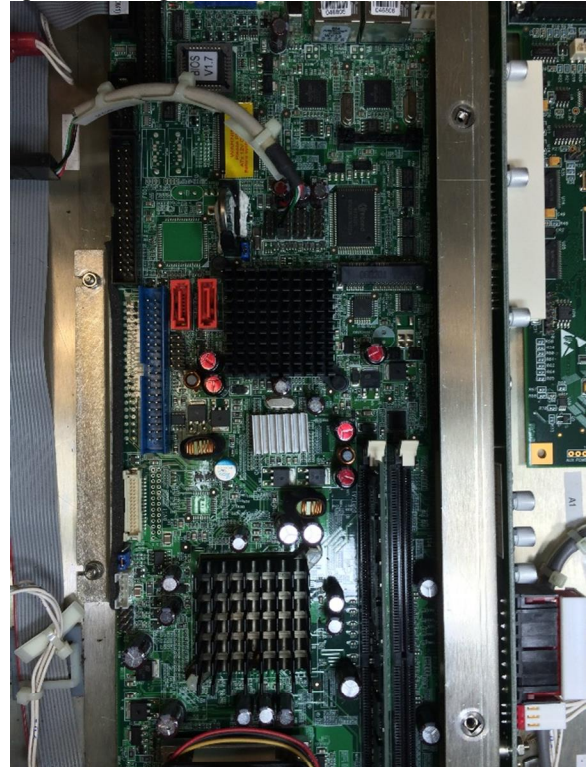
In this unit, only four of the five caps that I had replaced in the first unit were bulged out at the top, but I thought it wise to replace all five anyway. I did that, and in about 20 minutes the unit was back up and running on the bench.

**The capacitors marked in red in this photo are the ones that should be replaced on the Nautel Exporter Plus SBC.**

First, the photo above shows the five caps that you should replace in red. Replace them all, whether or not all are showing physical signs of failure.

Next, to remove the caps, heat the pad on the underside of the board while pulling the cap sideways on the top of the board, away from the lead being heated. Alternate between the two pads, pulling in the opposite direction until the capacitor comes free. It took me just two shots to get each cap out.

With the caps out, use solder wick to clear the solder from each hole. Sometimes this works and sometimes it doesn't. If it doesn't work, don't waste a lot of time continuing to try to clear the holes.

worked great. Make sure your bit is no larger than the capacitor leads (0.5 mm). You're dealing with a plated-through hole in a multi-layer board here and you don't want to remove any of the through-hole plating.

If you don't have a 0.5 mm PC drill, the easiest course is to apply some solder to the holes, then first heat the positive pad on the back side and insert the (longer) positive lead from the top. Remove the heat and rock the cap around as the solder cools so that the lead stays loose in the hole.

Next, put the (shorter) negative lead right against the center of the pad on the top of the board and heat the corresponding pad on the back of the board. As soon as the solder melts, push the lead all the way into the hole until the cap seats against the board. Re-heat both the negative and positive pads, apply solder as needed. Clip off the leads and clean off the flux. I followed this procedure on a couple of the caps with no issues whatsoever (I drilled the rest).

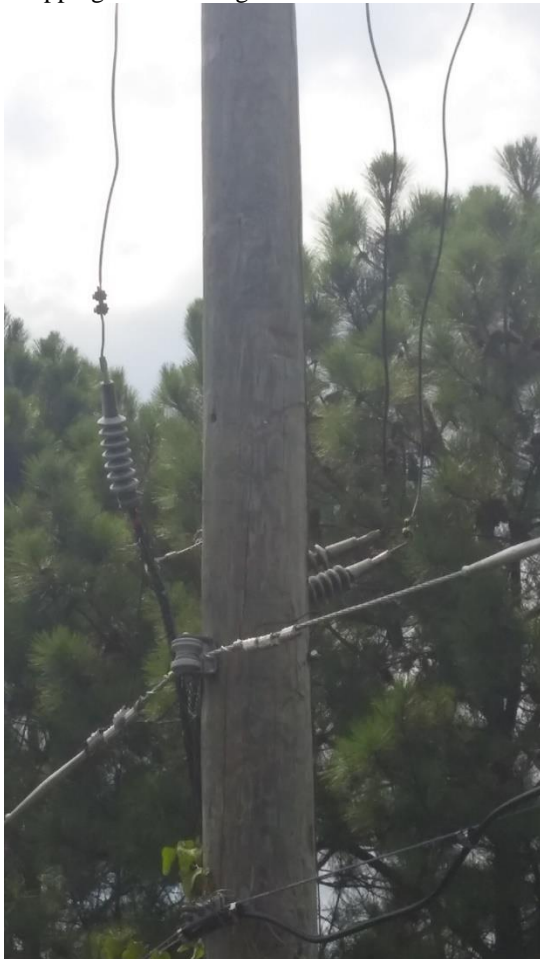
Once again, there were two line fuses popped on the power pole out front. I was pretty sure that it was the same pair, too, so my heart dropped. Boy, I was praying that transformer hadn't failed. Alabama had already replaced it once, so it was certainly possible. But when the tech from Alabama Power arrived, he replaced the pole fuses again and everything seemed OK.

**Not a great picture, but look at the insulators on the right. This is after the tech spread them.**

I pointed out to him that two of the phases on the high-voltage feed to our transformer were quite close together. He spread them apart and removed some vines from around the insulators, then popped in the new fuses. Thank you Lord! The power came back up and stayed up. No more öbooms.ö I still think those two insulators are too close, but at least I have a bit more protection against the wind whipping the wires together.

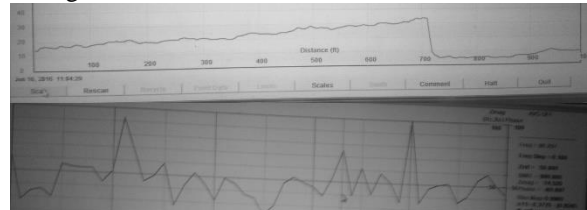
That may be; I don't know. What I do know is that we had to do some work to get him on air and operating legally. First, the switchover date was delayed when he discovered that the person responsible for the 99.1 translator antenna had done something wrong up on the tower. As a courtesy, Todd took our network analyzer and looked at it. The TDR gave a slowly-rising mountain, measured from the ground to the top. The impedance sweep was nothing but peaks and valleys. Yep, something was wrong.

**Another terrible picture. Top: TDR, bottom: Z sweep.**

The guy was able to get his antenna fixed, but there was another problem: he wasn't feeding legal IDs. We had no choice but to take the HD3 off air until he corrected that. This took a day or two.

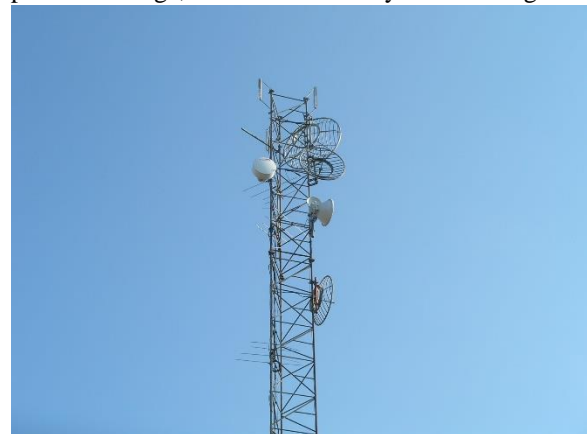
There's the proverbial saying, "Lightning never strikes the same place twice." I really don't think there is much scientific data to prove that, but geez, I hope it's true! A few days before the time of this writing, we had a grand mal lightning strike on our 80-foot STL tower at the studio/office location. Despite having a static dissipator and lots of grounding, the discharge tore through multiple systems, causing serious damage to many systems on the tower, throughout the rack room, studios and our offices.

**The 80-foot Pirod free-standing STL tower at the studio. Note the static dissipaters on the top.**

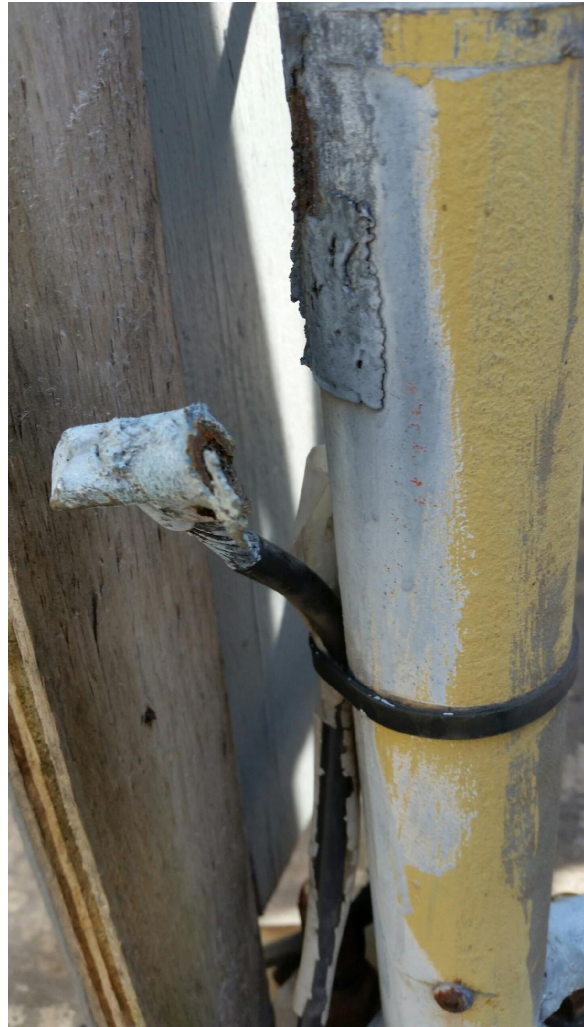
**After he wrote his column, Rick dug into the possible contributing causes of the lightning damage and found the above – the ground connection at the base of the tower was broken off. Someone probably hit it backing out of a parking space. We are getting a welder to come out and attach a new ground connection. -Ed.**

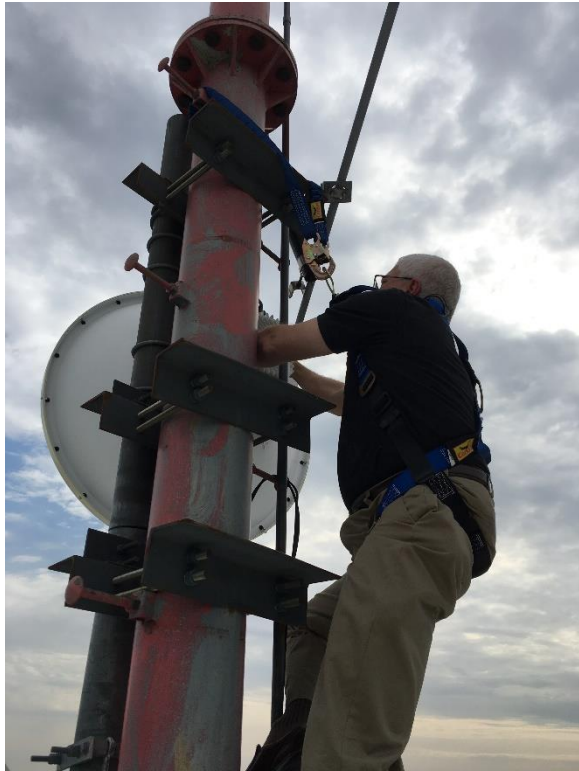
With everything at the transmitter end of the path eliminated, we decided that we wanted to go ahead and change out the Trango APEX radio at the studio with our spare APEX Plus. It would be cheaper to do it ourselves (free) than hiring someone to climb the tower. Because we don't have shielded CAT5 cable running from the engineering room to the roof (it runs in conduit), we did not have a power return for the APEX Plus radio, which uses the drain wire of the shielded CAT5 for a ground return for the power supply. Our only option was to locate the power supply on the roof, so we did that temporarily.

**The "old man" swaps out a microwave radio 160 feet in the air!**

We got the radio to power up, but never could get it to work ó it had the same IP address as another device on the network and we could not change it. We eventually gave up and put the original APEX radio back in place.

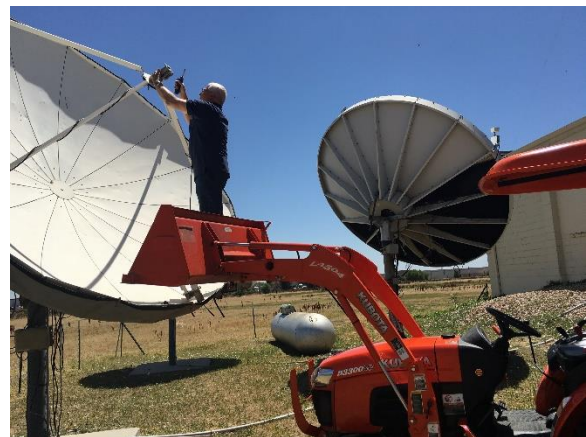
We had a day last month when we were having some issues with a satellite program. After arriving at the KLZ transmitter site, we immediately noticed tons of wasps hovering around our dish. We found the front (dish side) of the feed horn was broken and the wasps were making themselves at home inside. We sprayed it out really good with wasp spray and left it to dry. Keith went out there later on and used a ton of electrical tape to close it off

**The bucket of the Kubota tractor made a dandy work platform.**

so the wasps would not get in. We ordered a new feed horn since we could not find the cover that would fit.
