The Local Oscillator

The Newsletter of Crawford Broadcasting Company Corporate Engineering

APRIL 2010 • VOLUME 21 • ISSUE 4 • W.C. ALEXANDER, CPBE, AMD, DRB EDITOR

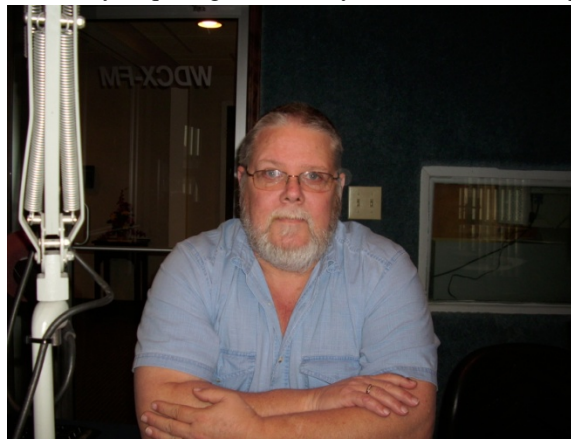
that usually can be obtained by only asking for it. Not long ago, while visiting a site I hadn’t been to in years, I noticed a couple of old Gentner VRC-1000

relay boxes sitting in a junk pile. When asked what plans the engineer had for them, he replied that they were replaced years ago and I could have them if I had a need for them. I don’t have any VRC-1000s in service, but I could use the 12 VDC relays out of the units along with the terminal strips, voltage regulator and heat sink. If I were to purchase these items from our local parts supplier, I would have

spent around \$50.00. A little bit of time invested in removing the eight relays saved about \$40, and the regulator transistor and heat sink another \$10.00. Will I ever use these items? Who knows, but I have them should the need arise, and they didn’t cost a cent.

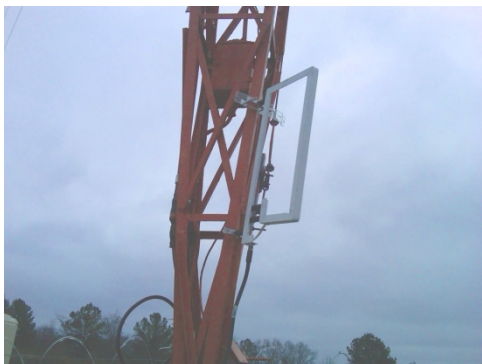
Figure 1 – Testing the completed sample loops

We got the sample loops finished and tested all of them in a known reference spot on tower #2. All of them produced exactly the same output with no measurable difference, which was absolutely beautiful. Next, we had to extend the existing sample lines to reach the loops, which would be mounted

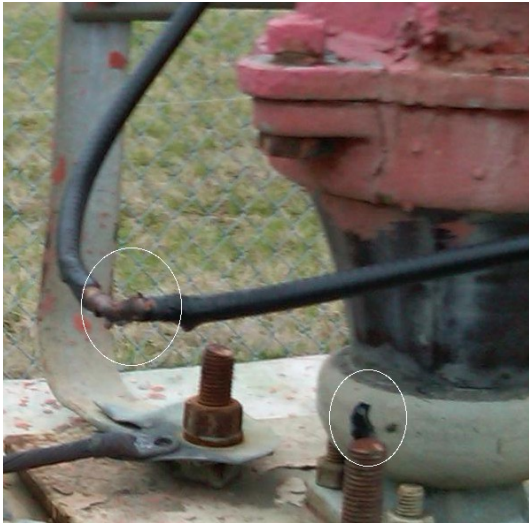
Figure 3 – Sample line pushed into the base by a severe storm

When you're in a hurry, you're likely to make stupid mistakes like the one shown in Figure 3. This one broke my heart; we'll have to repair this

sample line (and then re-confirm the electrical length and impedance) before we proceed. The base insulators on those ancient square-framed towers at Tarrant are very short (less than 8 inches) and this sample line drooped a little too far toward the grounded base of the tower. When the storm blew up later that evening, the high straight-line winds pushed the coax into the metal ring at the base of the insulator, burning out a small section of the sample line. We'll be able to repair it, but that's still aggravating.

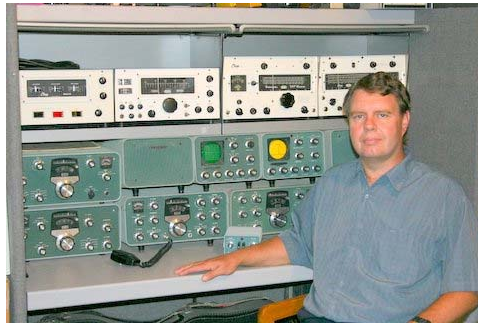
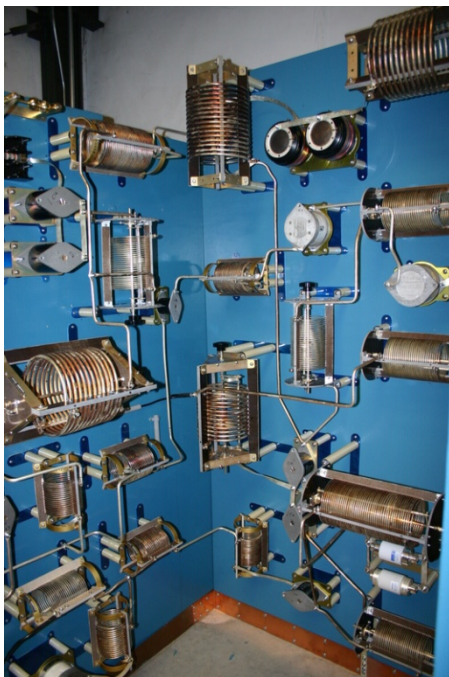
The new night phasor was built "Canadian Style" on laser-cut open panels

If the above measures were to fail and high power was applied to the night array, there are a couple of brute force protections built in to the phasor. At the input to the phasor I have installed a ball gap set to .028". This gap will allow operation at licensed power but should arc over and cause a shutdown of the transmitter should excessive power be applied. After the arc gap is a big fuse. That's just in case the arc gap does not fire. I found some nice big 600 volt fuses and a holder on eBay. By "big," I mean long. I want a fuse long enough that it's not likely to arc over from end to end if it blows.
