The Local Oscillator

The Newsletter of Crawford Broadcasting Company Corporate Engineering

APRIL 2014 • VOLUME 24 • ISSUE 4 • W.C. ALEXANDER, CPBE, AMD, DRB EDITOR

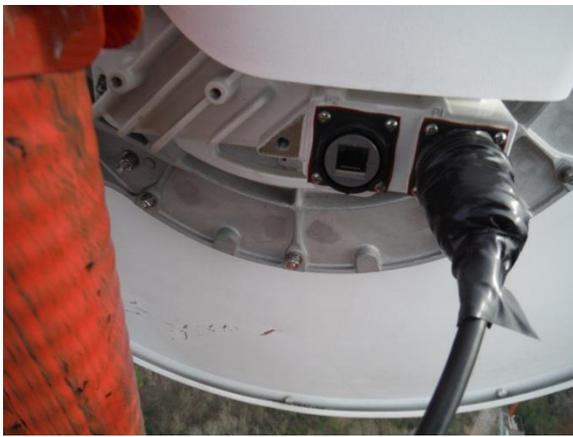
Figure 1 - Note the unused data port was left uncapped, and note the missing ground wire at the unpainted connection point to the left of the unused port.

Recently in Birmingham, we were having difficulty getting an 11 GHz microwave link to work properly. Try as we might, we could not get within 30 dB of the target receive signal level. Something was definitely wrong. The tower crew we hired to do

To get to the bottom of the situation, we hired another tower crew, one that specializes in carrier-grade microwave links. This crew went up the tower on both ends and took a lot of photos. As I looked at the photos, it quickly became clear that the original tower crew did not properly assemble the antenna mounts, they did not follow the manufacturer's instructions, they put one of the antennas some fifty feet above the licensed height, and they left the unused data port on the radio open to the elements. We would have known none of this had we not hired another crew to inspect the installation and provide us with photos.

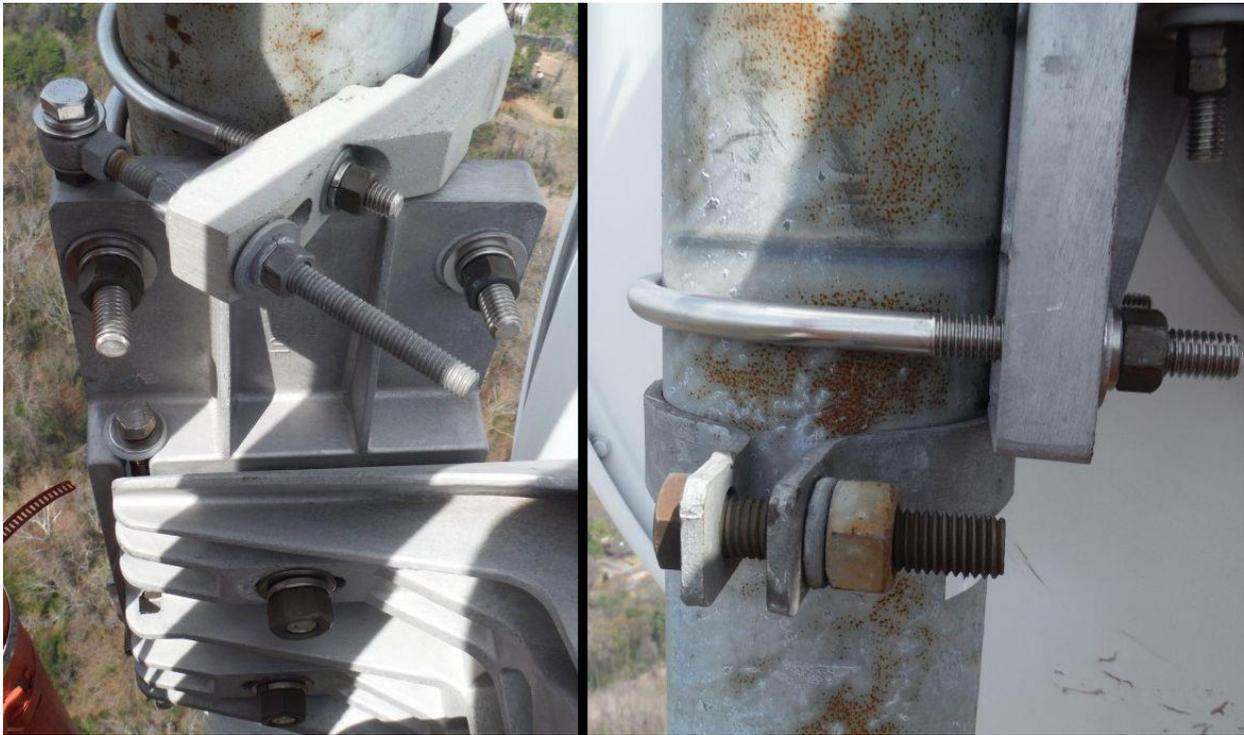
The next problem is that the fine azimuth (öAZö) adjustment is mounted on top of the bracket, rather than below. This might not seem important, but the way Radiowaves designed this thing, the heavy bracket (and thus, most of the weight) is supposed to sit atop that nice, beefy and polished stainless steel U-bolt. Instead, the bracket is sitting on a very thin galvanized collar that makes AZ adjustment more difficult. You canö loosen the clamps on the main bracket very much while youöre turning or the bracket will slip off that narrow collar. This adds time to the job (and risks damaging the AZ fine adjustment), costing us money. See Figure 2.

Figure 2 - Left: the AZ adjust incorrectly placed on top. Right: a cheesy, thin clamp supports the entire mount at the bottom

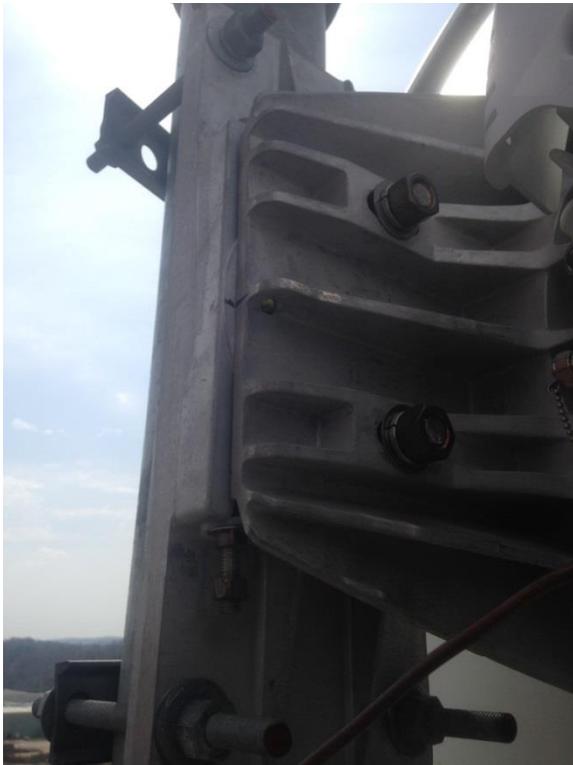
Figure 4 - At Tarrant, the factory-supplied hardware was replaced with flat clamps and all-thread

The biggest problem at Tarrant was that there was no azimuth adjustment at all. (!!!) The original Radiowaves/Dragonwave hardware had been replaced with some flat clamps (evidently waveguide clamps) and all-thread. The provided AZ clamp was never even installed. See Figure 3.

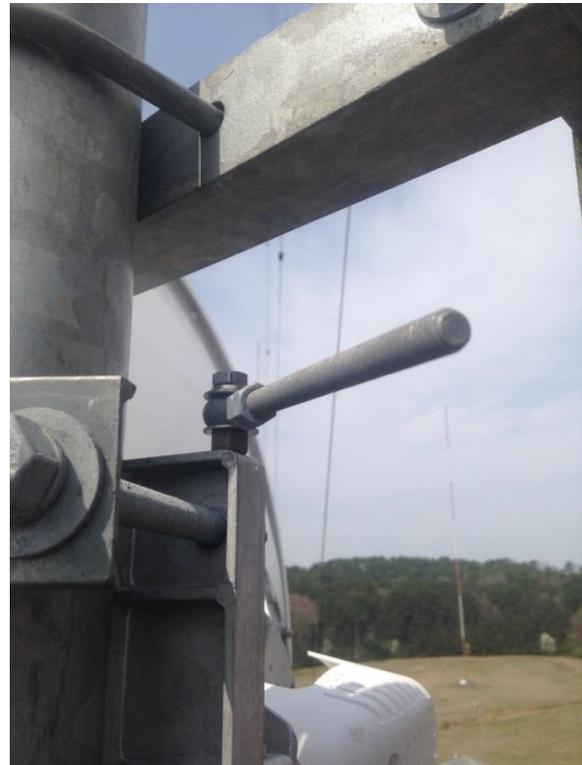
Figure 3 - The AZ adjust at Tarrant swings gently (and uselessly) in the breeze

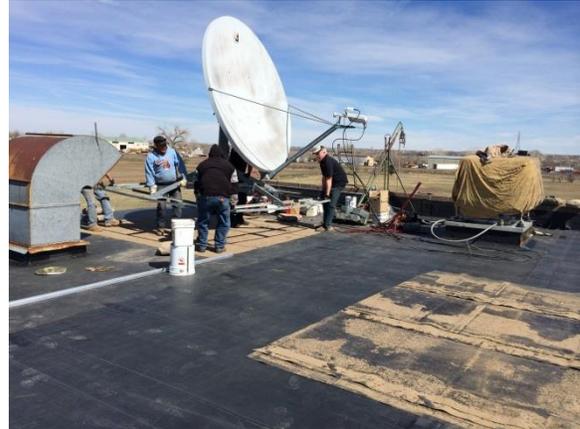
Our biggest issue going into this was the big satellite dish we use for the uplink. That antenna rests on a non-penetrating roof mount which is anchored with a bunch of sacks of concrete. We have several of our other stations that depend on us to send them certain feeds. We had discussed this a few times with the company, telling them that we would need to have it back in place by the end of the first day, meaning they needed to reroof that side first. They said okay, but apparently that didn't fit with their work schedule. They started on the other side of the roof and let us move the dish around lunch time.

With the ballast removed, four guys (that's my dad on the right) were able to lift and "walk" the uplink disk to a new location on the roof.
