The Local Oscillator

The Newsletter of Crawford Broadcasting Company Corporate Engineering

AUGUST 2013 • VOLUME 23 • ISSUE 8 • W.C. ALEXANDER, CPBE, AMD, DRB EDITOR

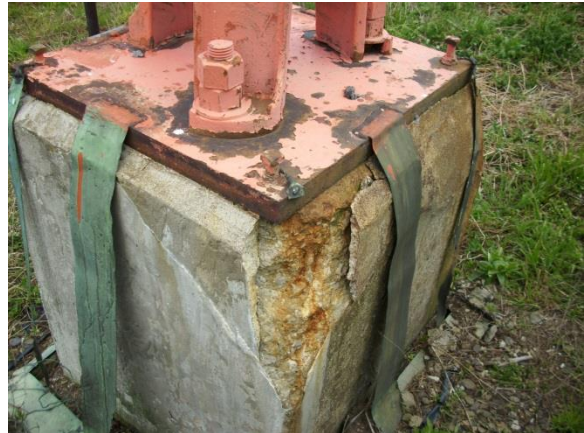
Other projects in the works are the painting of the five 245-foot free-standing towers at the WDCZ site, along with tower foundation repairs to seven of the foundation piers. Over time, large portions of the concrete piers have chipped away, mainly due to moisture entering cracks, then freezing, causing the concrete to break apart from the foundation form. The piers will not have to be replaced, just resurfaced and sealed to prevent any further damage to the structure. All of the tower ground strapping will have to be removed while the

work is done, and replaced when finished. Much of the grounding is old and has been patched many times over the years, so this is the opportune time to make permanent repairs to the ground system.

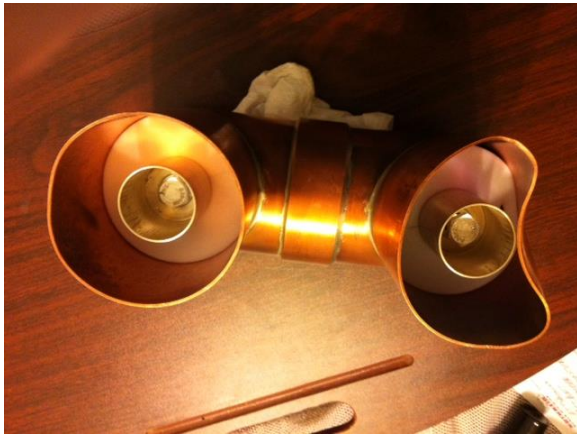
Figure 1 - Damaged 3-1/8" U-patch

This was no small deal. The U-patch was only a year or two old, and because it was custom (this particular patch bay had been out of print for several years) the replacement cost was well over \$600. This was not a throwaway. To my mind, it had to be repaired, but how?

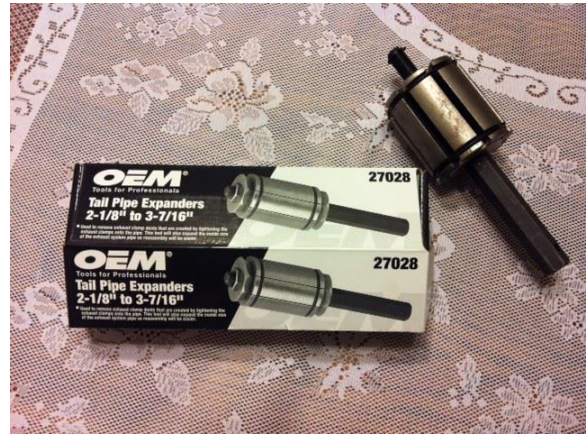
Figure 2 - Tailpipe Expander tool

I hung onto it for awhile, trying to figure out a solution. I then hit upon the idea of using a cylinder hone like the ones used for repairing car engines. My next door neighbor is really into restoring cars, particularly the muscle cars of the 60s and 70s, so I dropped over and showed him the situation. "I see your problem," he said, "but I have a better idea. Go to the auto parts store (and he named it) and rent a tail pipe expander tool."

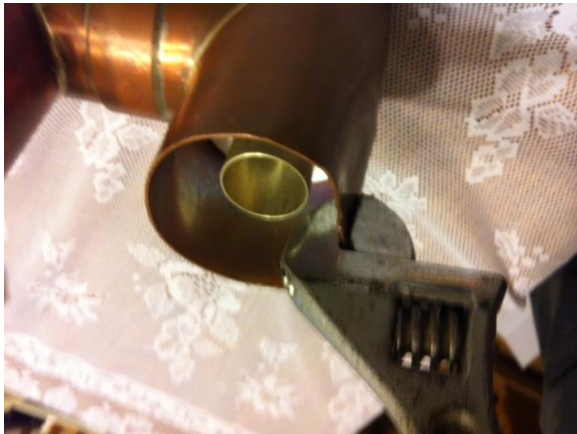
Figure 3 - Opening up the damaged U-patch

Even though the basic repair operation is easy to figure out, mastering the fine points of the job is not. In this case, I had to start by using a large crescent wrench and the screwdriver to open up the outer conductor enough to actually get the expander in. See Figure 3. Be *very* careful during this operation. You *don't* want to over-bend or literally rip the copper outer conductor.

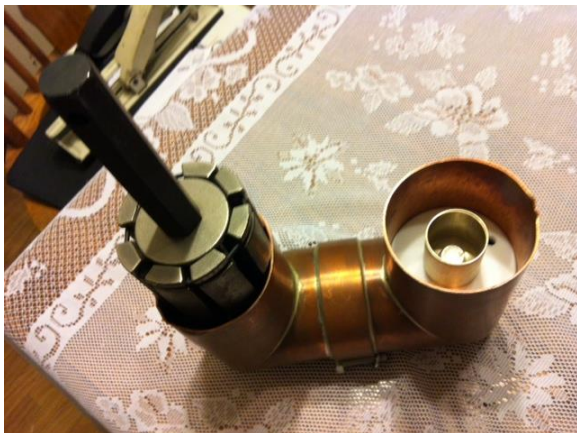
Figure 5 - Restoring the U-patch to round

Next, insert the completely collapsed exhaust expansion tool into the damaged outer conductor, as far as it will go. Use the crescent wrench to *slowly* expand the outer conductor back into shape. See Figure 5. Take your time; if you're doing it right it will take a while, maybe a half hour or even longer. You will need to occasionally stop and contract the expander to re-position its segments. There is a tendency for all of the segments to move to one side of the tool as it expands, so you'll have to work at keeping the segments at something close to equidistant from each other.

Use the mating flange to see how close you are to the proper circularity and diameter. Use the tape measure to make certain that the finished repairs makes the two vertical portions of the patch are the proper distance from each other (this distance depends on the design of your patch bay); use the ball peen hammer to *very gently* smooth out the circularity of the edge of the outer conductor from the creases which the use of the crescent wrench did to it earlier. Do this while the expander tool is in place and with a full wedge-face pushed up against the crease(s).
