The Local Oscillator

The Newsletter of Crawford Broadcasting Company Corporate Engineering

NOVEMBER 2016 • VOLUME 26 • ISSUE 11 • W.C. ALEXANDER, CPBE, AMD, DRB EDITOR

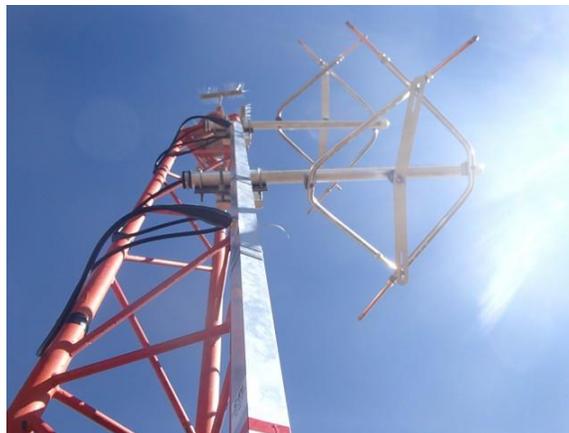
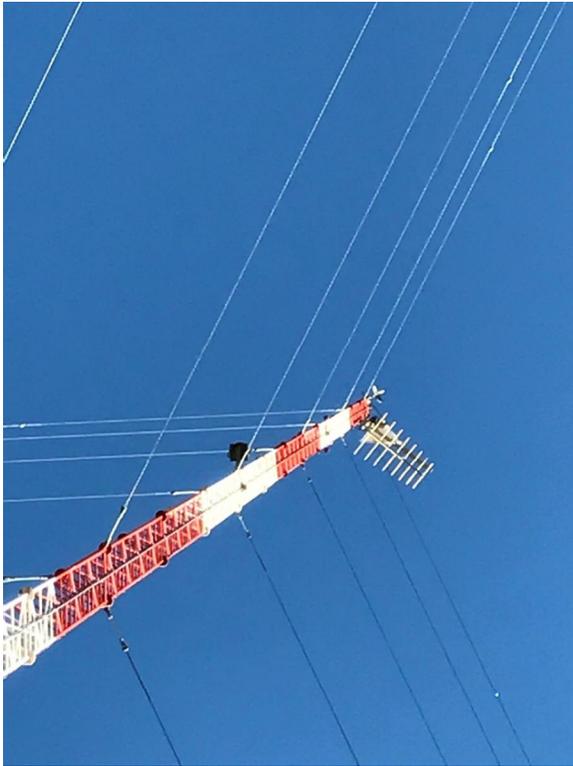
Figure 1 - The KLTT translator H&V antennas sit atop tower #4 in the directional array.

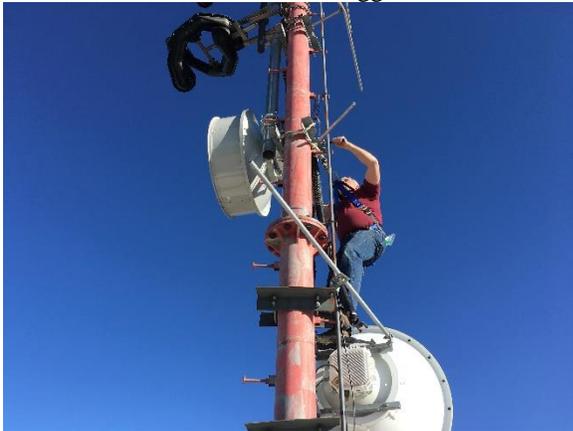
Figure 2 - The "old man" works 160 feet in the air, relocating the stiff-arm on the new 11 GHz dish to Lookout Mountain.

The new 3-foot dish was installed by the tower crew on the rooftop mast without incident. They had to fabricate a bracket to clamp a 4-inch pipe to the mast, but that all went fine. They eyeballed the dish onto the right azimuth (the Lookout Mountain towers are fairly easy to see from up there) and called it a day.

The next morning, I put on my harness and went up the mast. Amanda was my ground crew and we got the radio mounted on the back of the dish but not without incident. The tower crew had mounted the stiff-arm in such a way that it blocked the area where the radio mounts. I had to take all that

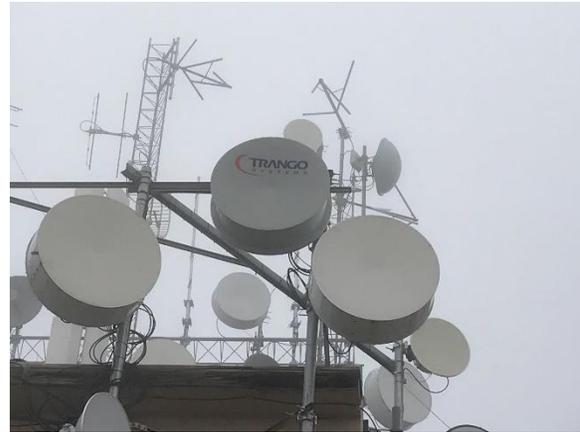
Figure 3 - This is sort of like a "Where's Waldo?" picture. The new Crawford 11 GHz antenna on Lookout Mountain is the one that says "Trango." The KLZ 100.7 antenna is visible above and to the left of the microwave antenna.

We had some trouble finding a suitable mounting location up at the Lookout site. The preferred mounting spot had a big pinon pine tree right in the aperture, so we had to find a different spot. Thankfully there was a location with a clear view of the studio.

The next trouble came when we couldn't use the DVM we had with us to monitor RSSI as we aligned the antenna. There is so much RF up there ó several megawatt UHF TVs plus a whole bunch of FMs ó that the DVM showed 100 volts or more DC when not even connected. The Trango Apex Lynx radio puts out a couple of volts DC for RSSI monitoring. You see the problem I'm sure. So we used the GUI and did the best we could, but there was so much lag that it was really just about impossible. We went to the other end and peaked the RSSI with that antenna, then grabbed a different DVM and a bypass capacitor. That did the trick. Back up at Lookout we were able to monitor the RSSI and get everything peaked up to be right on the path budget. We have -47 dBm at both locations now and a solid 47 mbps link. That cleared all the dropped packet issues we had been experiencing.

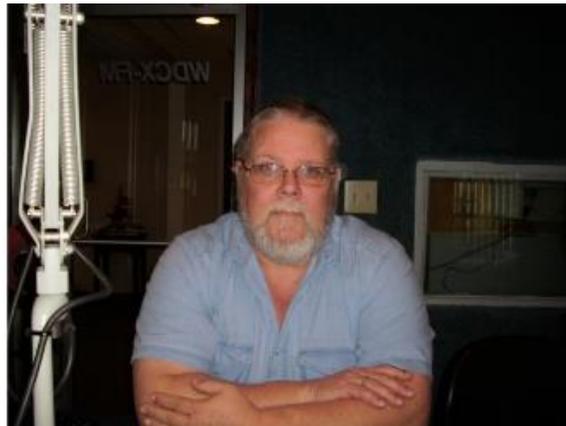
There are numerous items that need to be addressed each year, and if these are overlooked, could be potential problems at the worst times. First and foremost, I insure that each tuning house is clean

and free of any debris. You do not want any materials lying around that rodents can utilize to make nests in and around your networks.

After performing a thorough cleaning, I check each potential entry point that mice could enter, and seal it. Conduits that carry wiring into and out of the enclosures are stuffed with steel wool; mice cannot or won't eat through this material. I also strategically place moth balls around areas that mice would want to nest in.

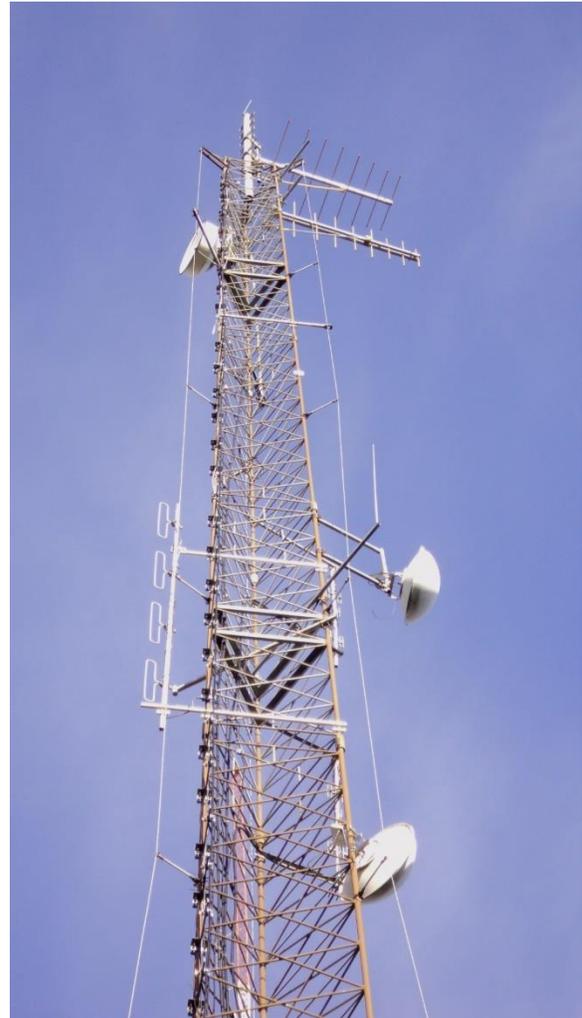
The KKPZ translator antenna at the top of the detuned communications tower on Mt. Scott.

communications tower just to the south of the KKPZ transmitter building. That tower has a 10-foot pylon at the top, which originally was used to mount a single-bay øroto-tillerø FM auxiliary antenna.

Initially, the size of the translator antennas was a challenge to fit into the space available at the top of the tower. A pair of vertically and horizontally polarized Kathrein

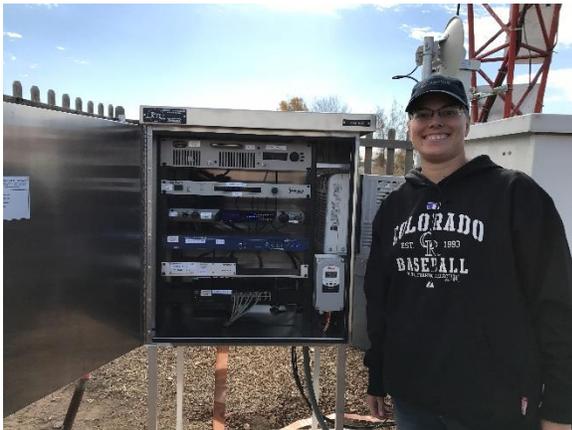
Amanda just finished installation of the KLTT translator equipment in the weatherproof, temperature-controlled cabinet at the base of tower #4.
