The Local Local Oscillator

The Newsletter of Crawford Broadcasting Company Corporate Engineering

SEPTEMBER 2011 • VOLUME 21 • ISSUE 9 • W.C. ALEXANDER, CPBE, AMD, DRB EDITOR

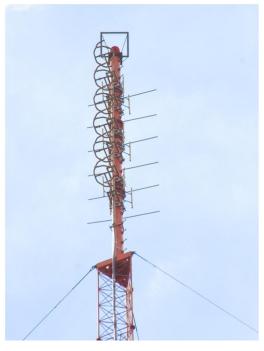
Ain't she just beautiful? The new WPWX main antenna makes her debut into the world. Even at half power, she's already making an improvement in our coverage. (Photo by Len Watson)

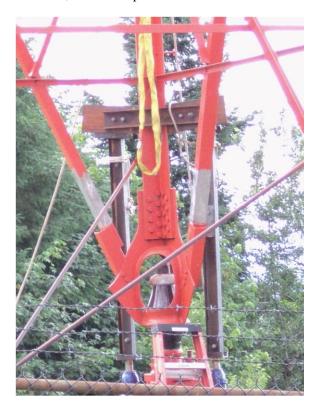
over the years, and that had to be checked prior to replacement. Referring to the photograph for reference, the next steps were as follows:

- 1. The cap nuts of the insulator base bolts were removed.
 - 2. Next, the nuts securing the bolts carrying

the structural load were backed off a half inch or so.

- 3. Any subsidence or shift of the foundation would show as movement of the insulator while the load nuts still provide positive control of the insulator. Ben Dawson has told me that he has seen insulators lift up under these circumstances. Any shifting of the base would show as movement of the insulator to the side.
- 4. If all is well, the jacks can now be used to lift the tower leg and insulator slightly $(1/8\ddot{o} \text{ to } \frac{1}{4}\ddot{o} \text{ at most.})$
- 5. During the lift, the insulator base is monitored for any indication of shifting. In our case, the lifting of both insulators went well and we were able to proceed to replacement.

To allow replacement of the base insulators, the first task is to provide support for the leg of the tower while the insulator is removed. Here, Jack uses jacks to provide the support needed. Yes, Jack is actually the name of the crew boss from P&R Towers. The jacks provided lift at each side of the tower leg. At the tower leg, a strengthened lift bracket provided the lift points for the leg.
