# The Local Oscillator

## *The Newsletter of Crawford Broadcasting Company Corporate Engineering*

AUGUST 2016 • VOLUME 26 • ISSUE 8 • W.C. ALEXANDER, CPBE, AMD, DRB EDITOR

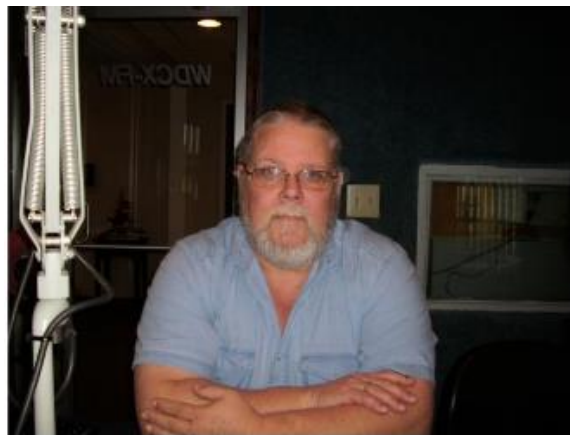
Last month, I had reported on an electrical problem at the WDCX-FM transmitter site. We were blowing 200-amp slow-blow fuses every couple days or so. In order to determine the cause of the failures, I purchased a good clamp-on AC ammeter with peak hold function and measured

the amperage draw on each leg of the incoming service. All three were exceeding 200 amperes for a brief period, but one phase, the one that kept blowing the fuses, had a peak draw of 260 amps!

To try and isolate the cause of the excessive amperage draw, I measured each phase with only the transmitter and ancillary equipment operating, then added the air conditioning and exhaust fans into the mix. Next, I measured the amperage at each disconnect, and found that the A/C units were causing the excessive amperage draw.

I called in our HVAC contractor to check out our two Bard 5-ton air conditioners. They soon found the cause of the problem. One of the units' electrical connections into the compressor was arcing, due to high resistance connections on the 3-phase electrical mounting block. He stated that Bard used a special type of connector on the service wires, and these connectors are a known component to fail with excessive use. He replaced the wiring harness to the compressor, and cleaned the condensing coils on both units, as they had clogged up in just a matter of weeks since they were checked. Since this work was done, we have not experienced any fuse failures, and the amperage draw on the main service is below 200 amps.

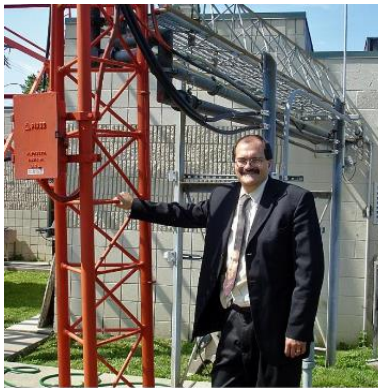
From the message on the front panel of the unit, it seemed that I lost the authorization to use the codec license supplied with the unit. It seemed

strange since it was purchased with all the installed audio codec algorithms straight from the manufacturer. Bill had me look at some of the menus, including the one that shows the installed codecs. We found that one to be blank. In addition, the field that shows the serial number of the unit was also blank.

At that point, he wanted me to try to load the license file from the Tieline server over the internet. Through some menu navigation, we gave that a try, but it was not able to load them. Bill indicated that he would create a license file and send it to me in an email with some directions. When I received the email and file, I tried to set up IP communications between the two units. In order to do that, I put the Disto on our other network switch with a different ISP service. Almost immediately, the Disto grabbed the license file from the Tieline corporate server and loaded it. Now I could see the serial number and codecs loaded on the display.

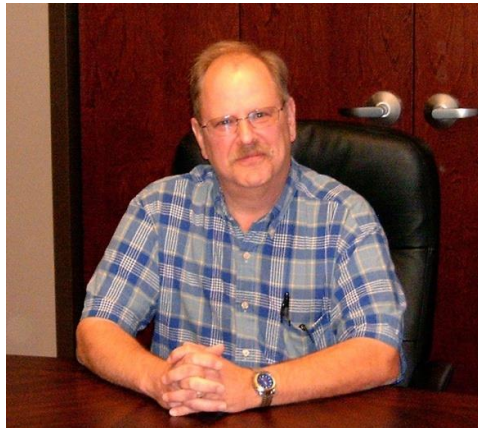
Eventually, everything was back to normal and we made it through the rest of Friday. But Saturday night, July 23, I received a call from the operator at the studios. He had heard a very loud "boom" and the power was out again. This time, the UPS units did their job and the generator took over the load. We were on air, but I drove in to the studios

Once again, there were two line fuses popped on the power pole out front. I was pretty sure that it was the same pair, too, so my heart dropped. Boy, I was praying that transformer hadn't failed. Alabama had already replaced it once, so it was certainly possible. But when the tech from Alabama Power arrived, he replaced the pole fuses again and everything seemed OK.
