# The Local E Oscillator

The Newsletter of Crawford Broadcasting Company Corporate Engineering

# APRIL 2012 • VOLUME 22 • ISSUE 4 • W.C. ALEXANDER, CPBE, AMD, DRB EDITOR

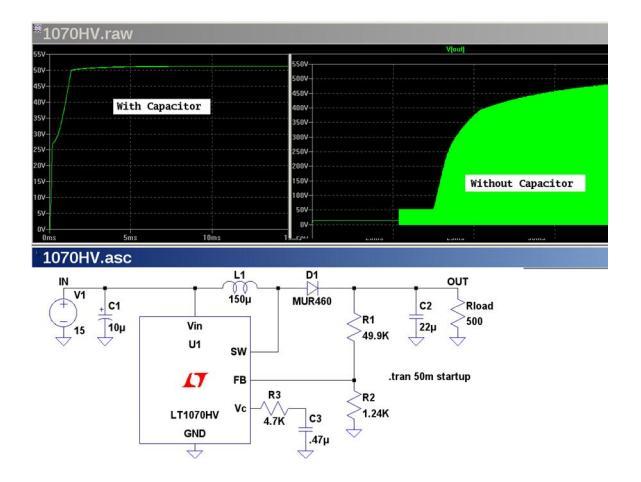
Figure 2 - A typical SMPS in "Boost" mode

Figure 2 is an LTSpice simulation (discussed last time) of a typical SMPS using Linear Technology's LT1070 monolithic regulator. The PWM generator, the regulator and switching transistor are all built into the chip, making it easy to create a "boost" regulator circuit. I'm taking a 25V input and "boosting" it up to 50V into a 500 ohm load, or 100 mA of current.

" $V_{IN}$ " and "Gnd" are the supply and ground pins, respectively. "SW" is the collector of the switching transistor, "FB" is the feedback voltage that tells the regulator what the output is up to and " $V_{C}$ " is the compensation. More on that in a moment.

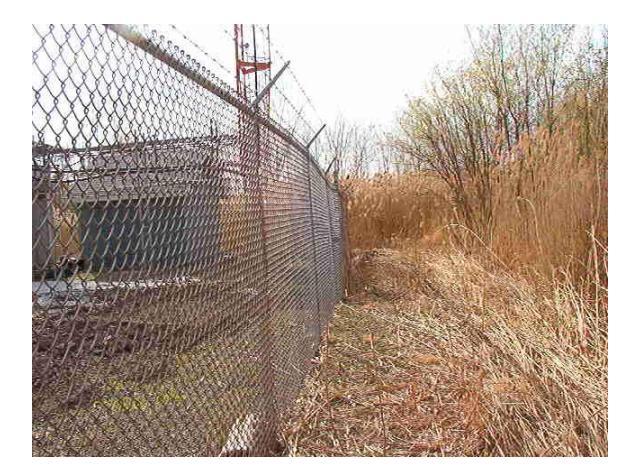
Weeds around the compound fence at the WPWX transmitter site

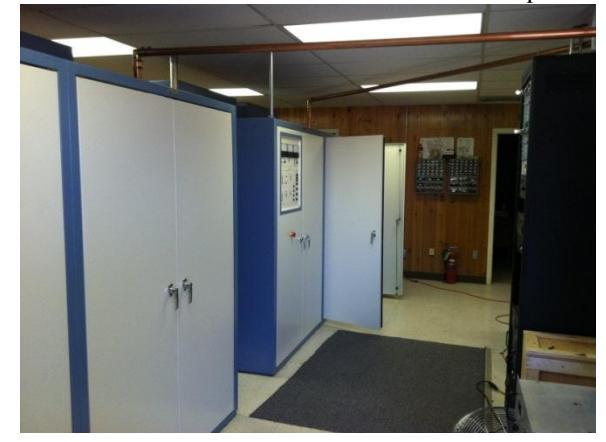
KCMN/KCBR Transmitter Room – the XL30 with the doors open is KCBR's

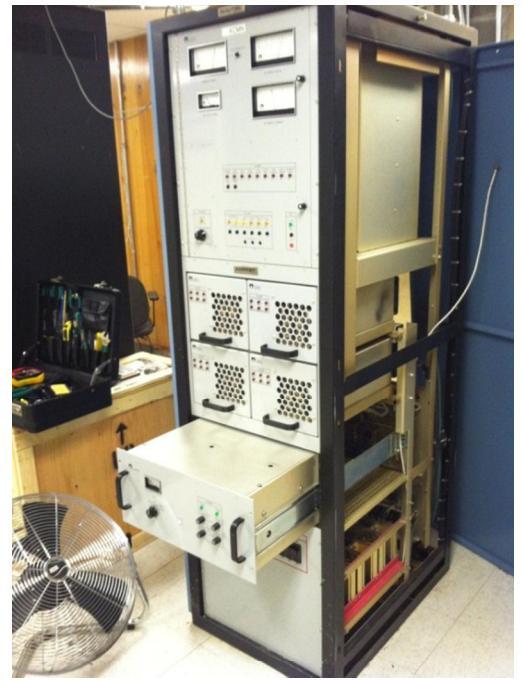
#### KCMN ND5 – note the "fix" that the contract engineer had applied (exciter drawer open with a fan blowing on it). I guess it worked...

There was one more problem. The ND-5 for KCMN had what we thought was exciter trouble. Every time we have been out there the last couple of years, the exciter drawer has been pulled out and a box fan has been blowing on it. The contract engineer had evidently found that when it got warm in the room the transmitter would act up. We pushed it back in, turned the transmitter on into the dummy load and ran it at full power. It wasn't long before we began getting a Low RF Drive alarm. The weird thing was, it would flash several seconds before finally turning the transmitter off.

We had replaced U9 in the PDM driver, which was a known thermal issue in transmitters of that vintage (Nautel had unknowingly received a bad batch of those ICs back when the transmitter was made). That didn't work. With the help of Nautel's Jeff Welton, we zeroed in on the B-minus switching supply and found that its output was indeed quite low and got lower with heat. We were able to bypass the power supply to get the transmitter running, and we brought the power amp back to the office to troubleshoot. Everything tested fine, so we went ahead and replaced a capacitor and "shotgunned" all the active components (the MOSFET, two bipolar transistors and two ICs). Hopefully that will fix our issue and we will have both KCBR and KCMN back to 100% when we take the power supply back to Colorado Springs. I have been enjoying a change of scenery and the learning experience this has provided me with.
